MTL TR 91-31

METALLURGICAL AND MECHANICAL ANALYSES OF A FAILED FUSE HOLDER FROM THE XM264 ROCKET

WEGO WANG, JOHN C. BECK, and MARTIN G. H. WELLS
METALS RESEARCH BRANCH

August 1991

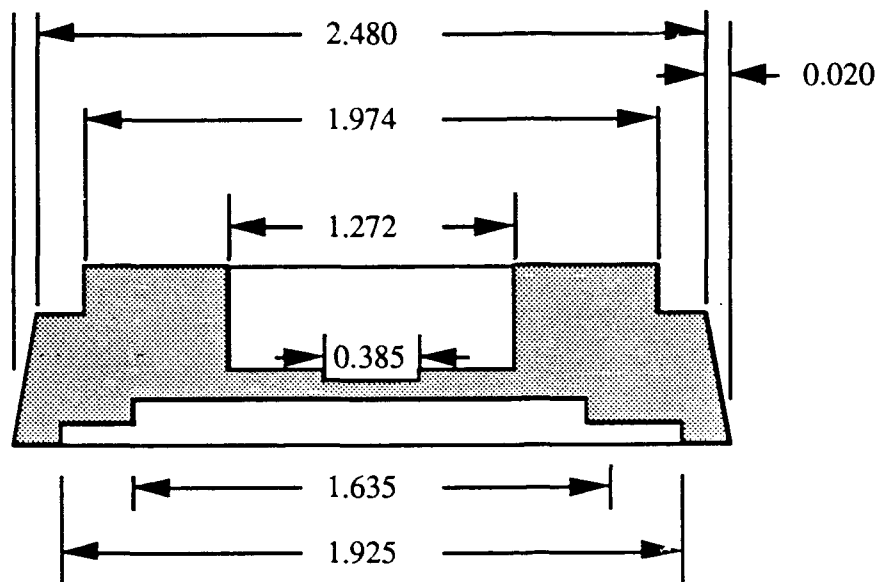
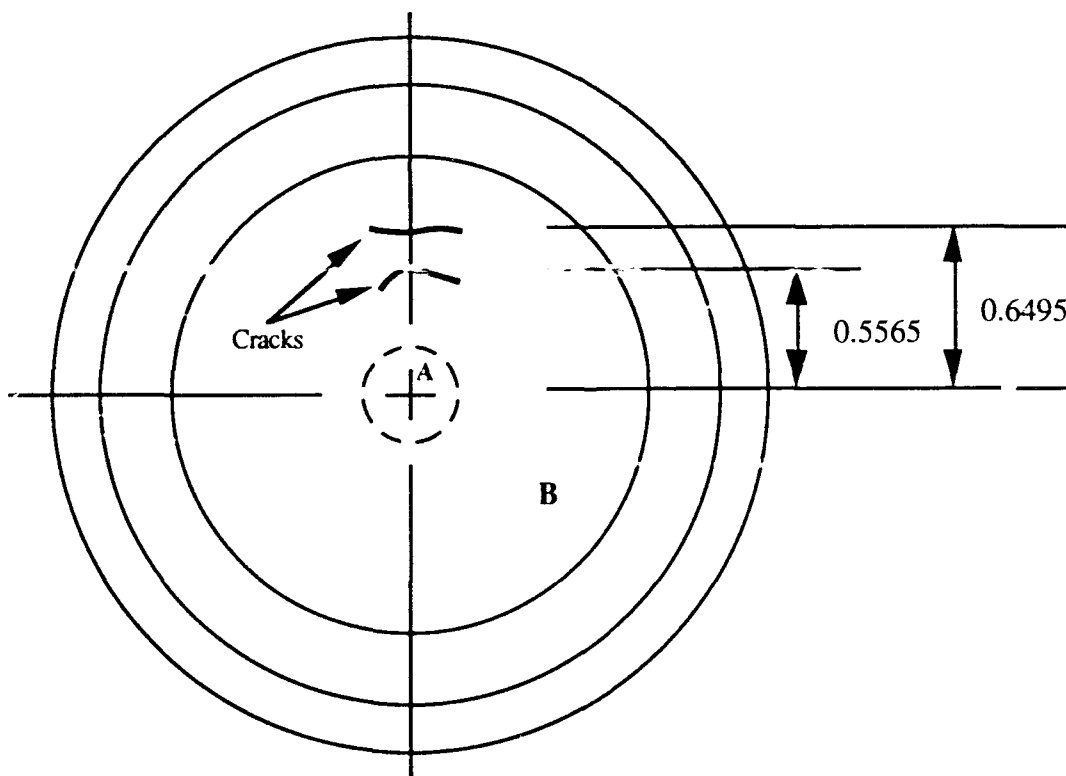
thickness (0.015±0.005). The surrounding center-disc thickness is 0.075±0.005 inch in the drawing, compared with an average measured thickness of 0.070 inch, or about 7% thinner than the nominal value specified. It also should be noted that the outermost circumferential surface is oblique by 0.020 inch (i.e. has a taper of 15°) which is not shown in the drawing. The measured dimensions are shown in Figure 2 which illustrates a simplified cross-section front view.

Figure 2. The measured dimensions of the fuse holder, in inches; A: center cup, specified and measured thicknesses are 0.015 ± 0.005 and 0.010 inch, respectively; and B: center disc, specified and measured thicknesses are 0.075 ± 0.005 and 0.070 inch, respectively.

It has been suggested in a new design that by increasing the thickness of the center-disc from 0.075 to 0.095 inch, the tolerable amount of explosive pressure and the resultant deflection can be improved as summarized in Table III.

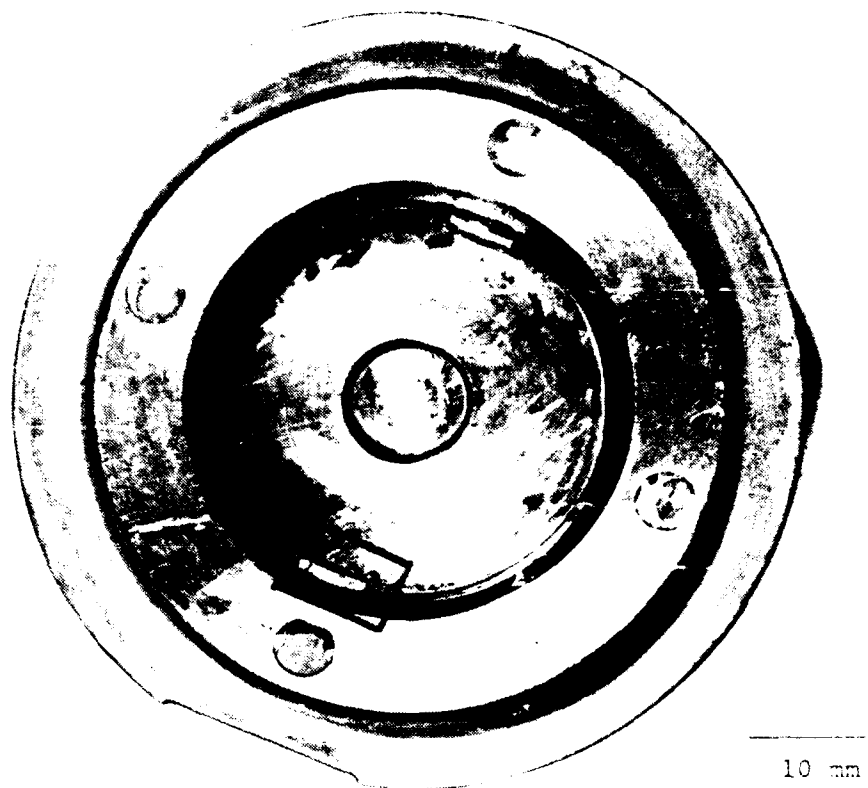
An overall macrograph of the fuse holder casting is shown in Figure 3(a). A large crack located directly underneath the wall edge of the internal side in which the explosive charge firing occurred was observed as shown in Figure 3(b). Two surface cracks were found on the external side as shown in Figures 4 (a) and (b). The dimension measurements indicate that these two cracks are located directly opposite the inner surface recess wall. Several secondary cracks are scattered around the above-mentioned primary cracks. However, no cracks propagated completely through the thickness of the center disc.

Figure 3. The internal side of the fuse holder showing a primary crack directly underneath the wall edge as indicated by the arrow.

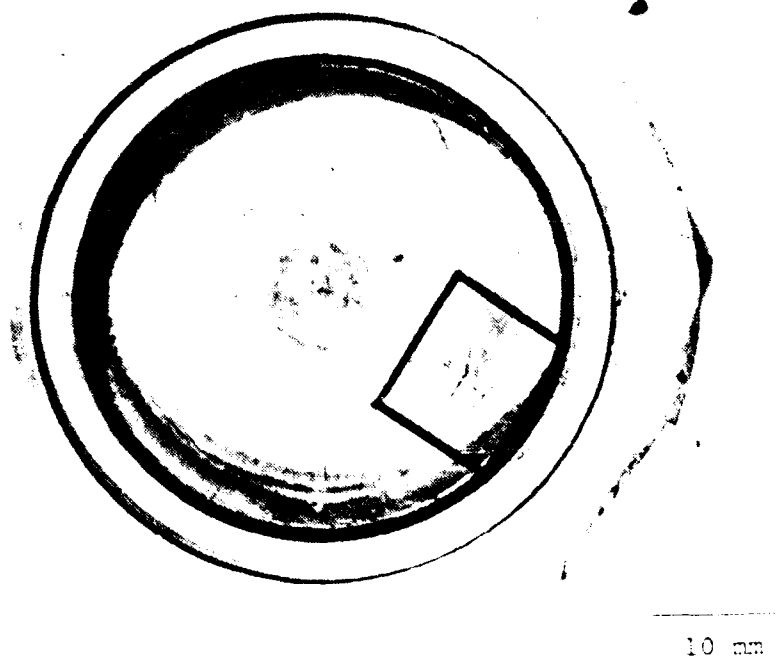
Figure 4. The external side of the fuse holder showing two large cracks.

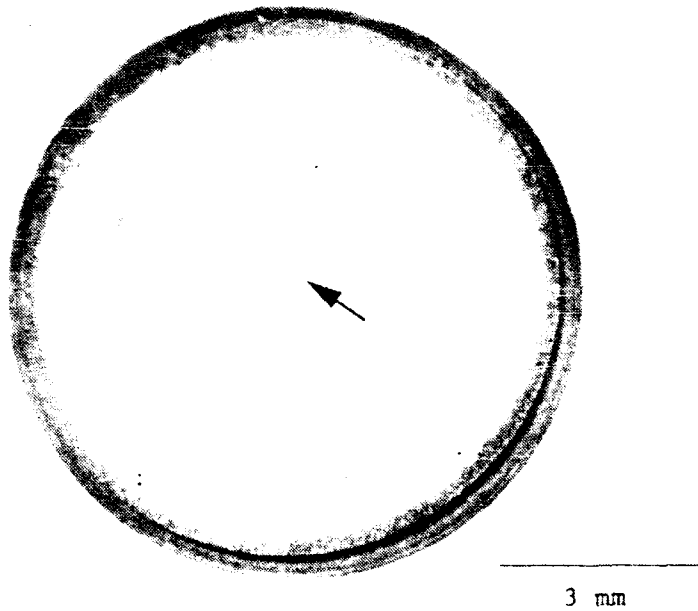
Figure 5. Optical metallograph showing the early development of cracks in the center-cup area as indicated by the arrow.

The local explosive pressure resulting from fuse ignition is not expected to be uniformly distributed. The "true profile" of the local explosive pressure was not available. However, the values summarized in Table II provide a reasonable estimate for design purposes. Without considering the safety factor, i.e. safety factor = 1, the maximum tolerable explosive pressure is 269.25 psi for avoiding stressing the 380 aluminum alloy above its yield strength with a maximum deflection value of 0.0085 inch occurring in the center. Using a safety factor of 2, the maximum tolerable explosive pressure is 134.62 psi with a maximum deflection of 0.0042 inch in the center. Compared with the large measured deflection value in the center-cup area, 0.005 inch, the finding is alarming. The calculated explosive stress corresponding to this 0.005 inch deflection is 200 psi, which is larger than 134.62 psi; thus it is not surprising to find small surface cracks in the center-cup area.

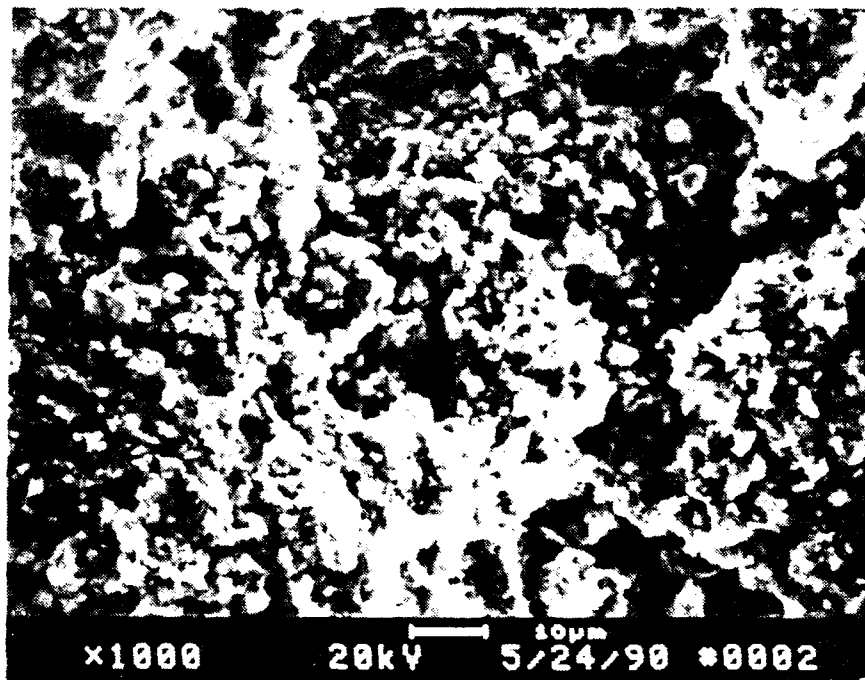
Figure 7. A typical fracture surface showing ductile matrix with cracked brittle particles.

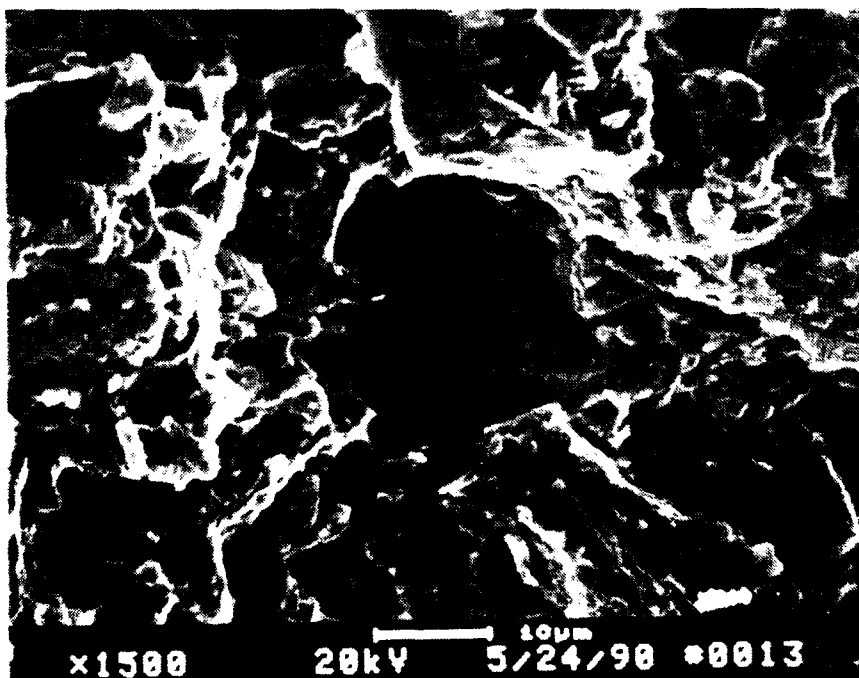
Figure 8. A fracture cavity caused by cracking of an Fe-rich particle.

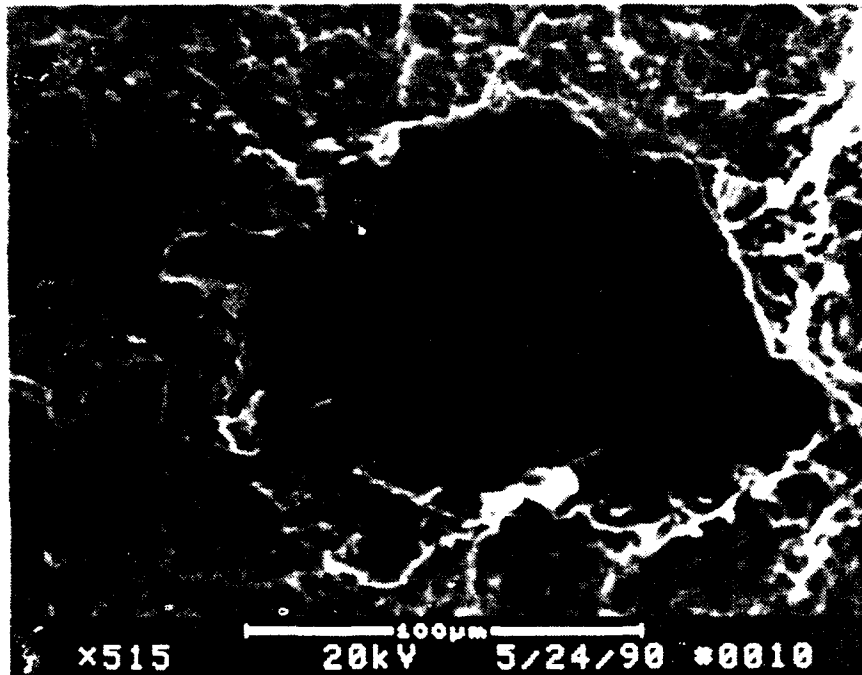
A relatively large (about 150 μm) aluminum particle was observed as shown in Figure 10. This soft aluminum particle did not show any signs of brittle cracking. Though it did not initiate a crack, it did not halt crack propagation. It served as a soft region in the matrix and weakened the overall material strength. Residual aluminum particles should be eliminated by better process control. In addition to this aluminum particle, a few unexpected impurity inclusions and particles were observed as shown in Figure 11. Particles were either Cu-, Mn-, or Fe-rich, respectively. Most second phase particles were very small and presented little direct threat for crack initiation. The observation of a Pb-rich particle, as shown in Figure 12, was unexpected. This Pb-rich particle might come from the explosive charge or other accidental contamination.

Figure 10. A residual aluminum particle observed on the fracture surface.

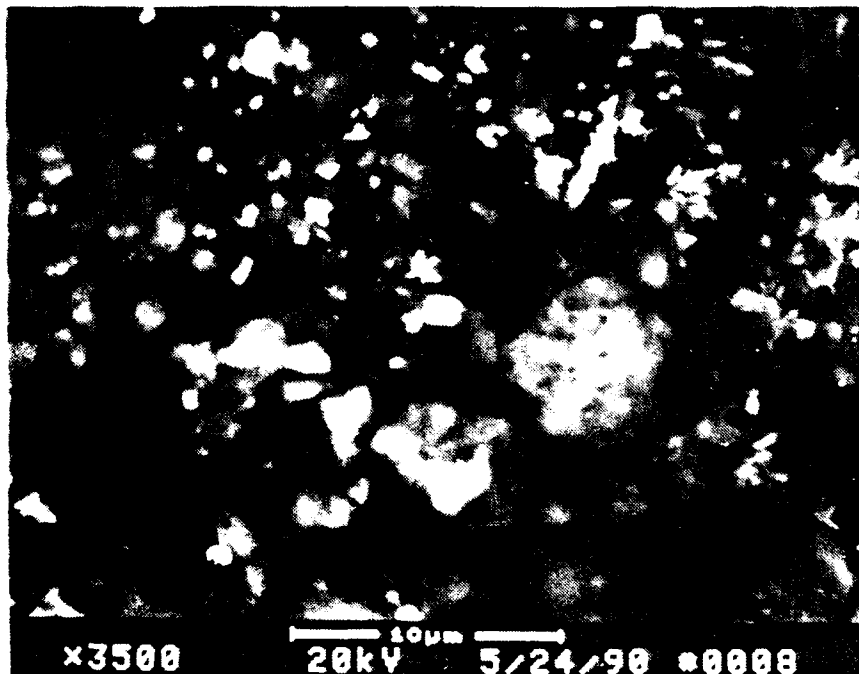
Figure 11. Foreign inclusions and particles observed on the fracture surface.

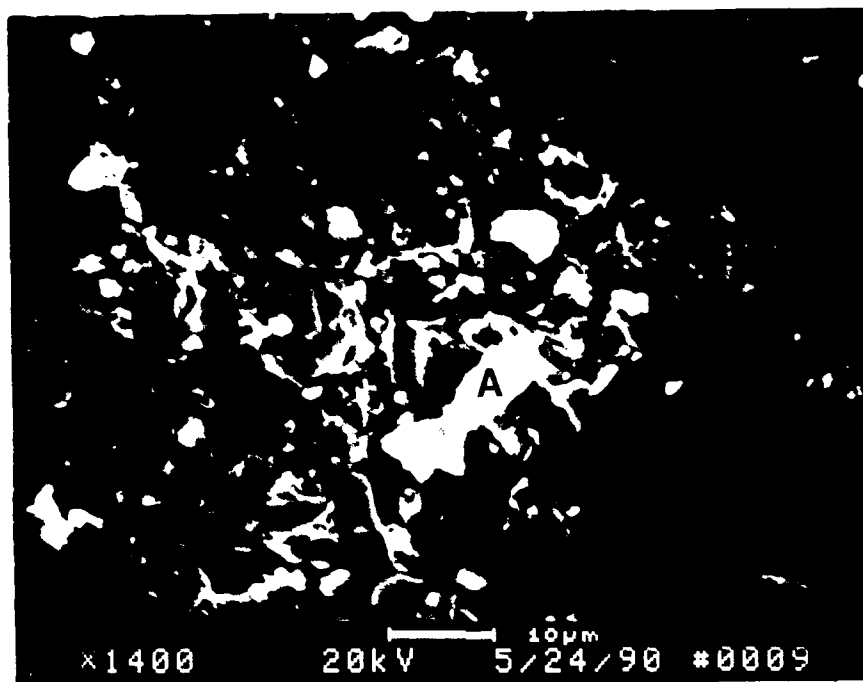
Figure 12. Pb-rich particle, A, observed on the fracture surface.
